EVALUATION COUNTING SYSTEM FOR TRUCKS ON THE PWC OFFENBAU

Part: V&R ParkDetek

On behalf of the central office for traffic management in the Bavarian Road Administration

Dresden, October 2012

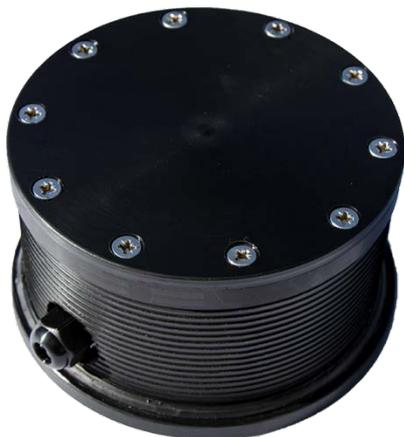
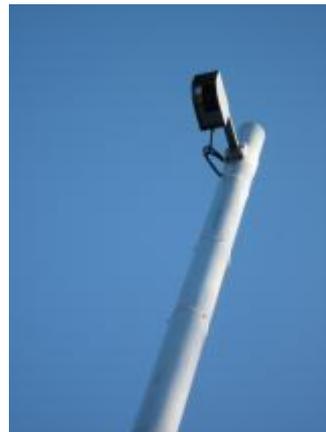
The system of V&R consists of two or more »MultiSens«- cross sections with an outdoor laser scanner (Class 1 infrared laser, »ScanSens-X0«) and a ground radar sensor (»GroundSens«).

The laser scanner performs the task of vehicle detection, as well as measuring height and width. The ground radar measures lengths and speeds, and also classifies the vehicles into typical vehicle categories.

Fig. 01: Ground radar »GroundSens« and laser scanner »ScanSens-X0«

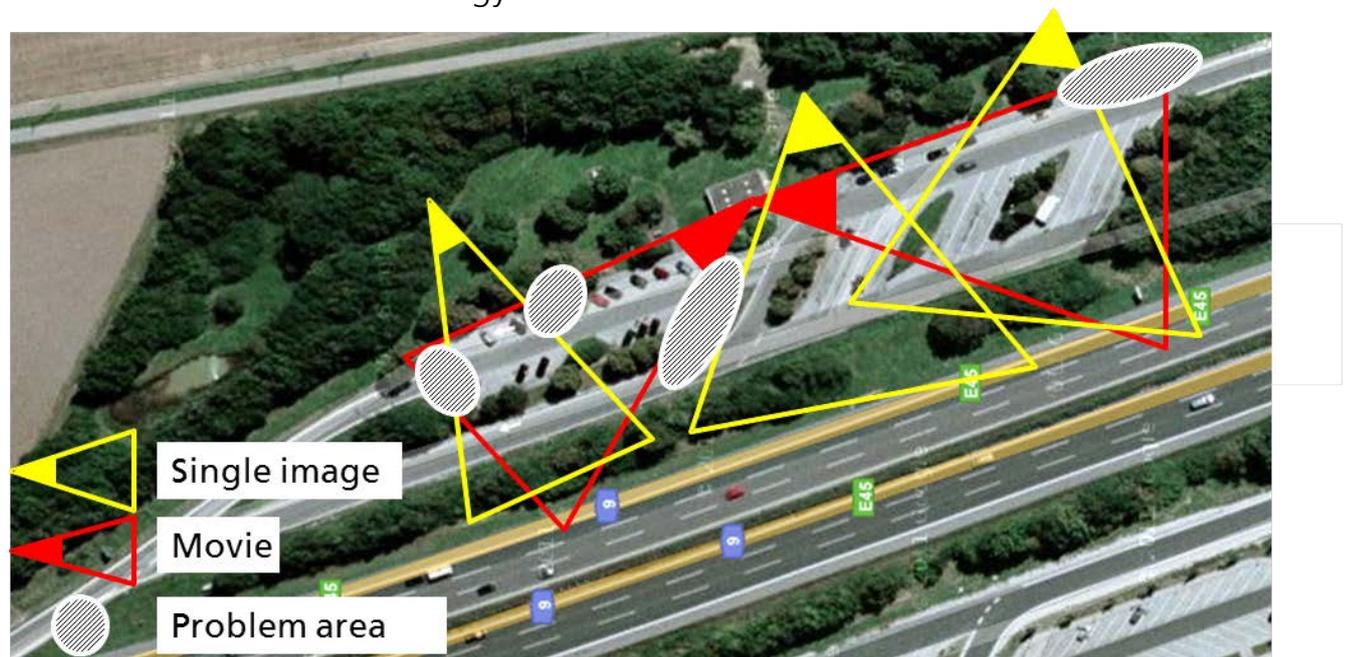
At the test site, there are six cameras available for remote observation. Five cameras are documenting the occupancy of the parking area, thereof videos have been recorded by two cameras and single images have been taken by three cameras, see fig.02. Another one is aligned to the detector in the entrance. This one was observing incoming vehicles only.

Fig. 02 : Camera locations for visual occupancy sensing

- Limited field of view by siting (see fig. 02)
- Restricted view by masking and glare
- Incompleteness of recorded data (data gaps of different size)
- Offsets between the V&R-system and the different cameras.

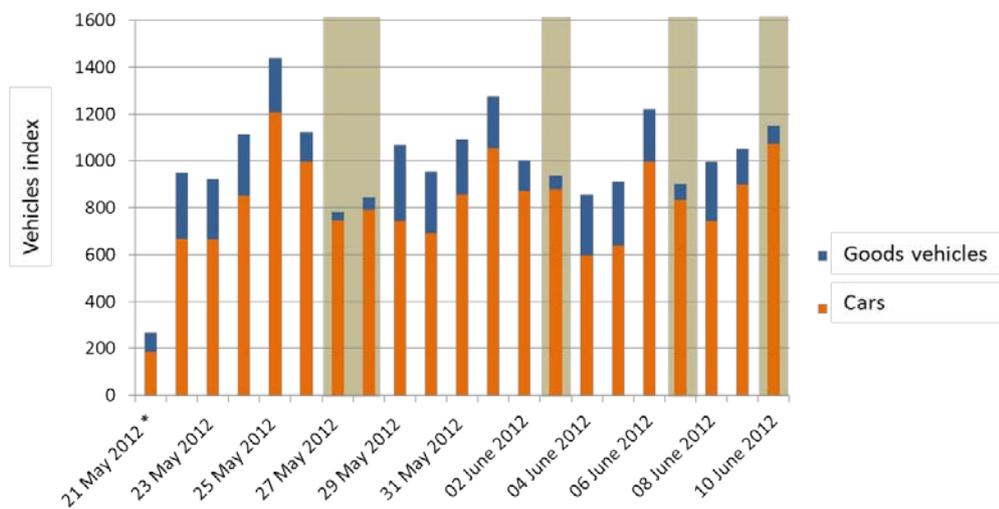
Fig. 04: Observation at the entrance (greyed: Sundays and holidays)

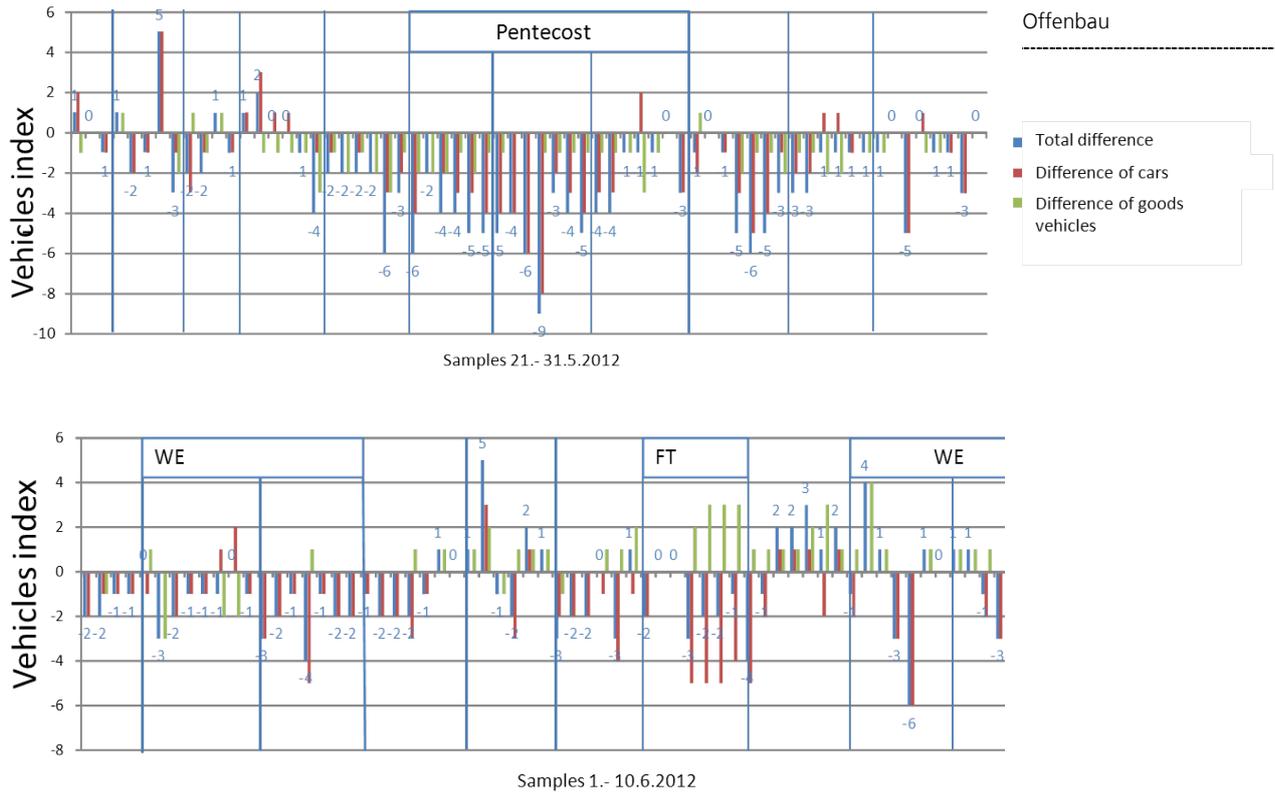
The following diagram depicts the deviations for all vehicle types over the whole period of observation, calculated as the difference of counted values of the reference and measured values of the V&R-system. Weekends are marked with »WE« and the holiday Corpus Christi is marked with »FT«.

The heavy deviation on the second measuring day may be attributed to a short-time heavy rain with high traffic volume. At this time, some vehicles have not been identified, for example because they followed too closely. Above, the system was disturbed on 6th June (Tuesday before Corpus Christi) because of survey work in the exit area.

Fig. 05: Total deviations

During the three weeks of measurement, the number of error detection or classification did not build up, therefore the system showed a good long-term stability. In the test period, except one measurement, the system obtained **+/- three good vehicle units** in maximum. The deviations for motorcars were in some cases considerably higher, partly due to masking and »blind angles« because of the positions of the cameras and partly due to wrong classification of motorcycles as well as of ambiguously classifiable vehicles between the classes »lorry-like« and »motorcar-like«. The last issue can be found in neutralizing deviations of lorries and cars. For both vehicle types applies that differences between reality and reference system may occur due to bad visibility during night (darkness or glare by punctiform light sources).

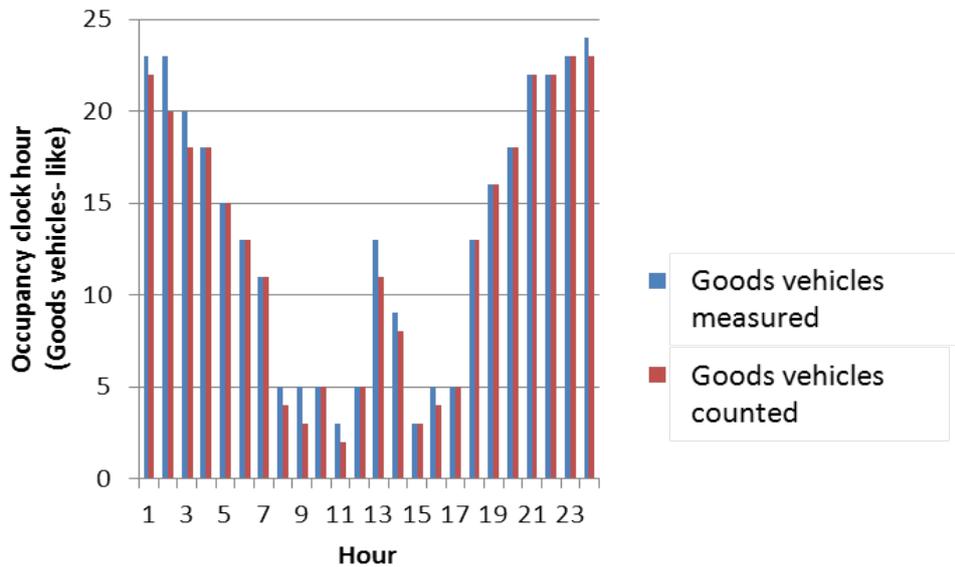
Fig. 06: Goods vehicles-samples for 24 hours

- Lorry-like vehicles (maximum occupancy: 23 lorries, mean occupancy: 13)
 - Mean difference: 0.5 vehicles
 - Maximum difference: 2.0 vehicles
- Motorcar-like vehicles (maximum occupancy: 15 cars, mean occupancy: 6)
 - Mean difference: 1.0 vehicles
 - Maximum difference: 3.0 vehicles.

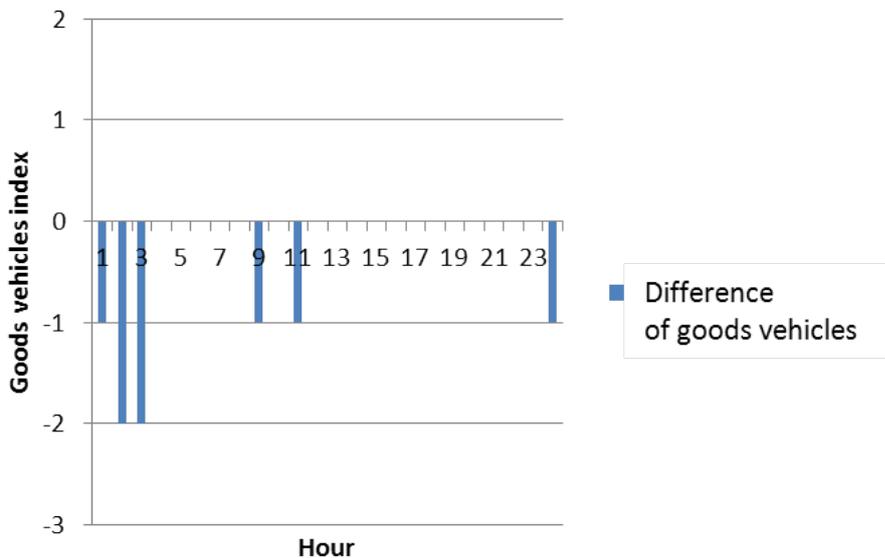
Fig. 07: Difference of samples of goods vehicles for 24 hours

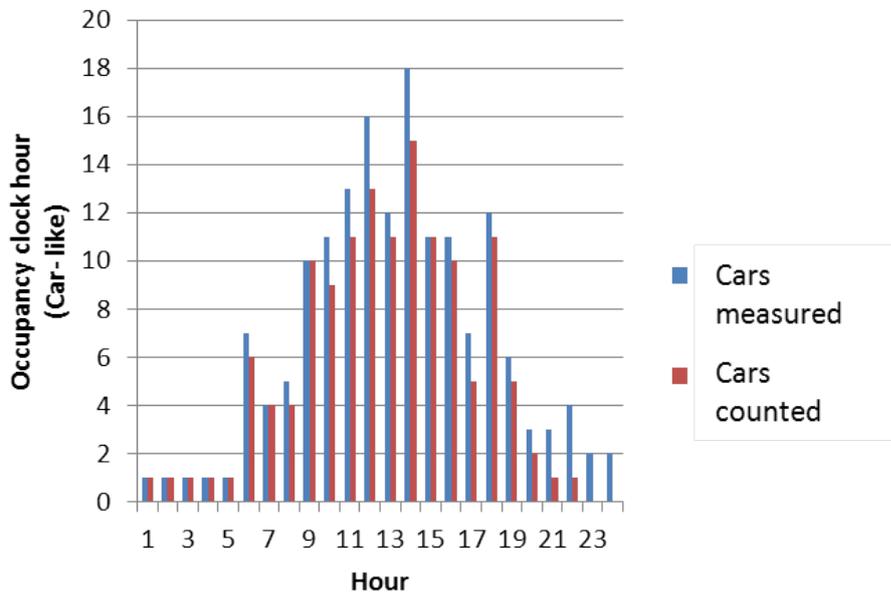
Fig. 08: Sample of cars for 24 hours

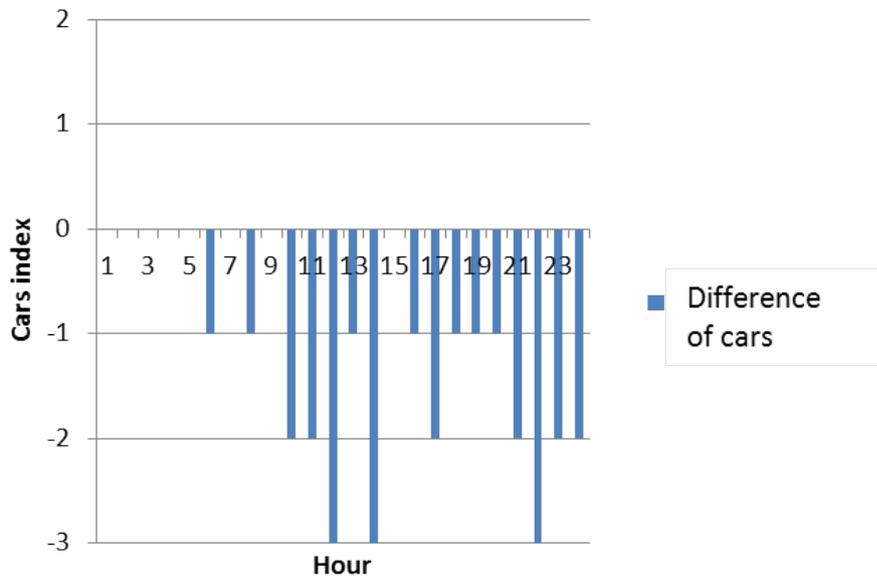
Fig. 09: Difference of sample of cars for 24 hours

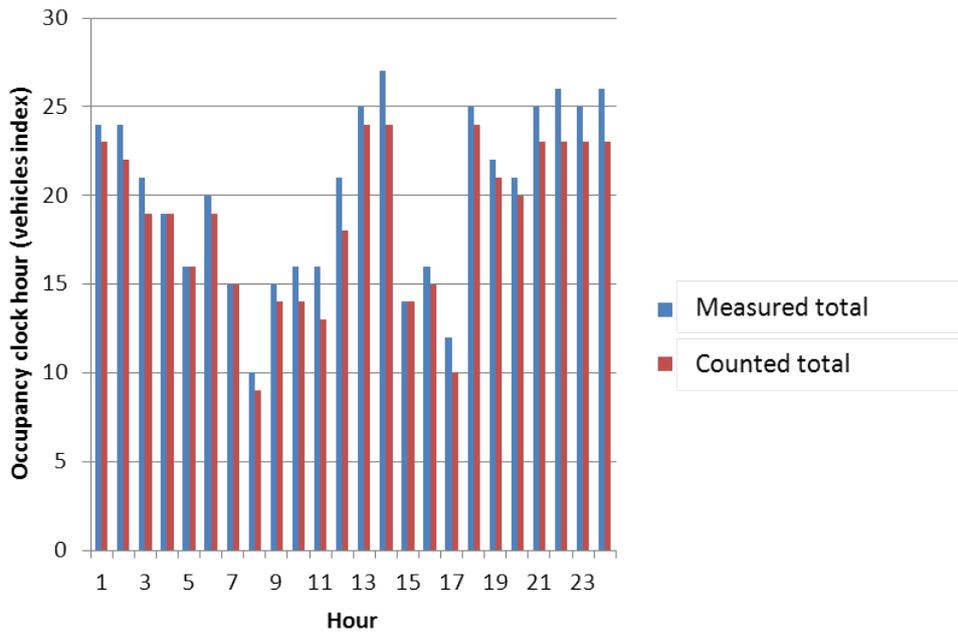
Fig. 10: Total number of vehicles in one day

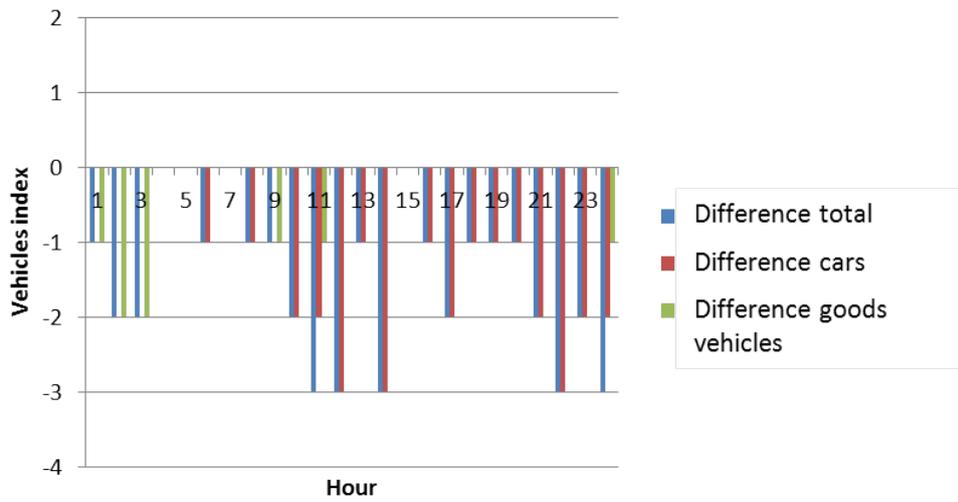
Fig. 11: Difference of all types of vehicles

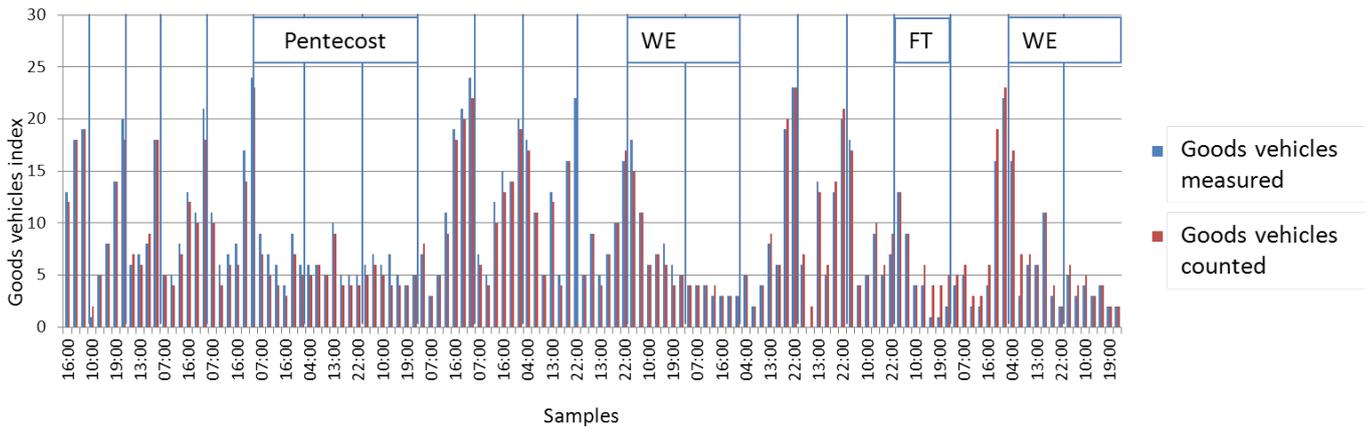
Fig. 12: Sample of goods vehicles for total period

The following charts show occupancy measurements for the complete period for goods vehicles, cars and vehicles in general. Data were collected only if enough video data were available. In the chart, weekends are marked with »WE« and the holiday Corpus Christi is marked with »FT«.

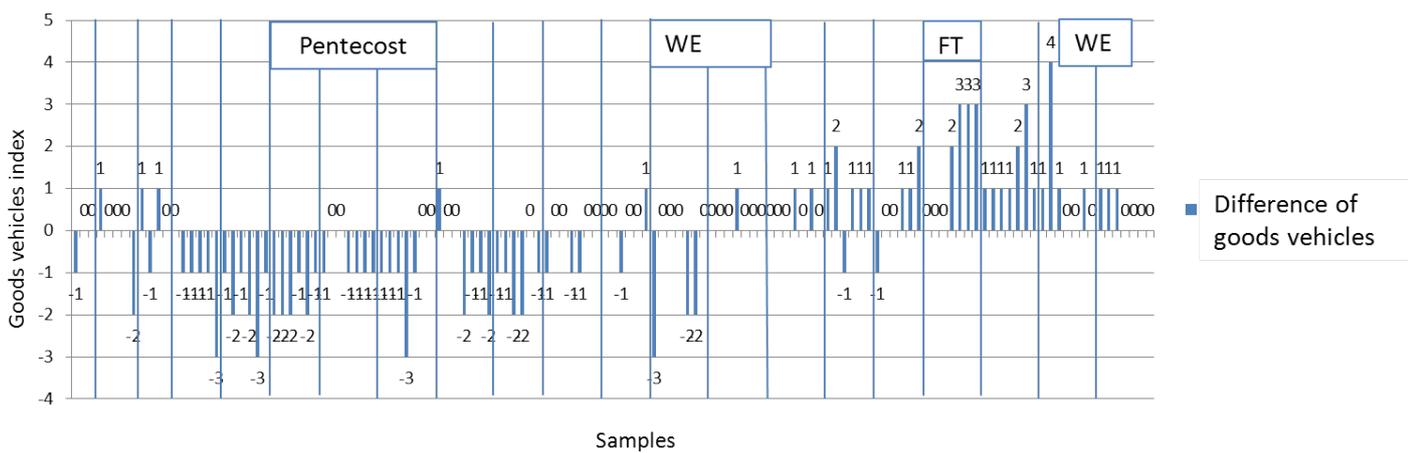
Fig. 13: Difference of sample of goods vehicles for total period

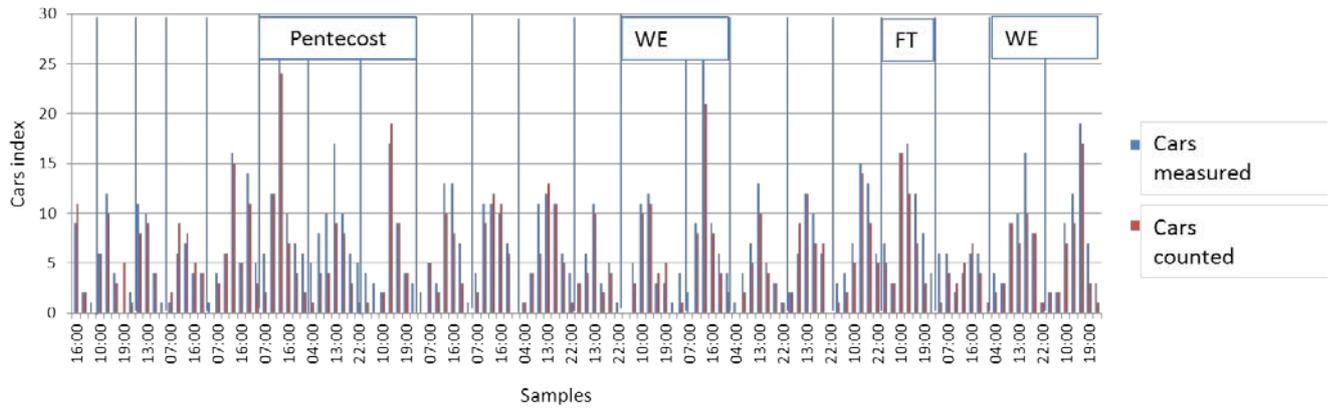
Fig. 14: Sample of cars for total period

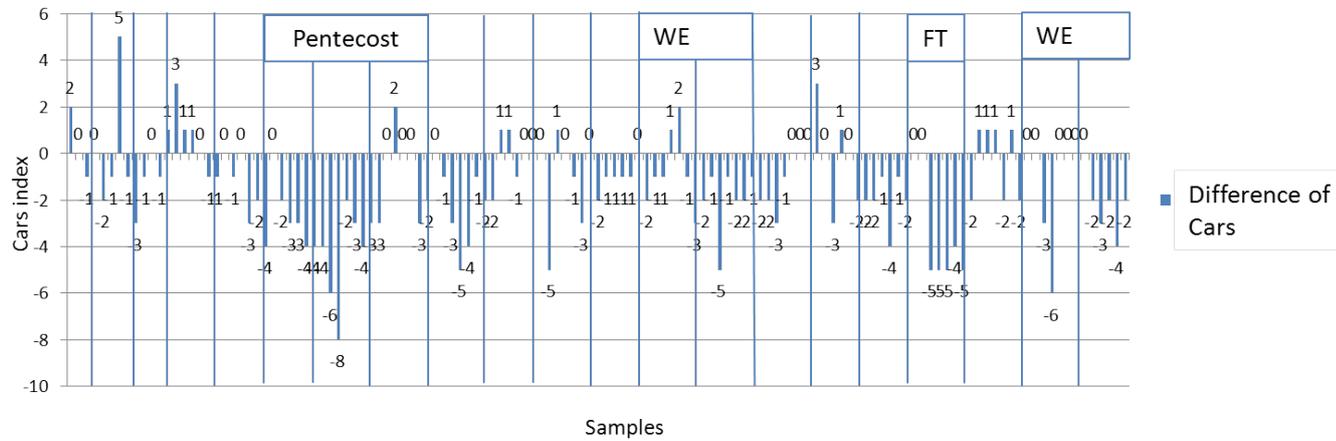
Fig. 15: Sample of difference of cars for total period

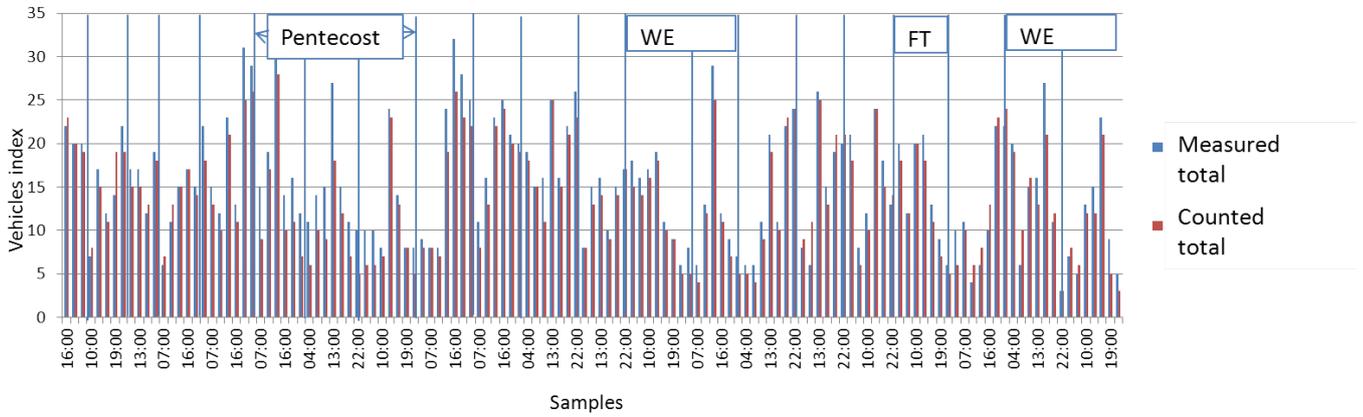
Fig. 16: Sample of all vehicles for total period

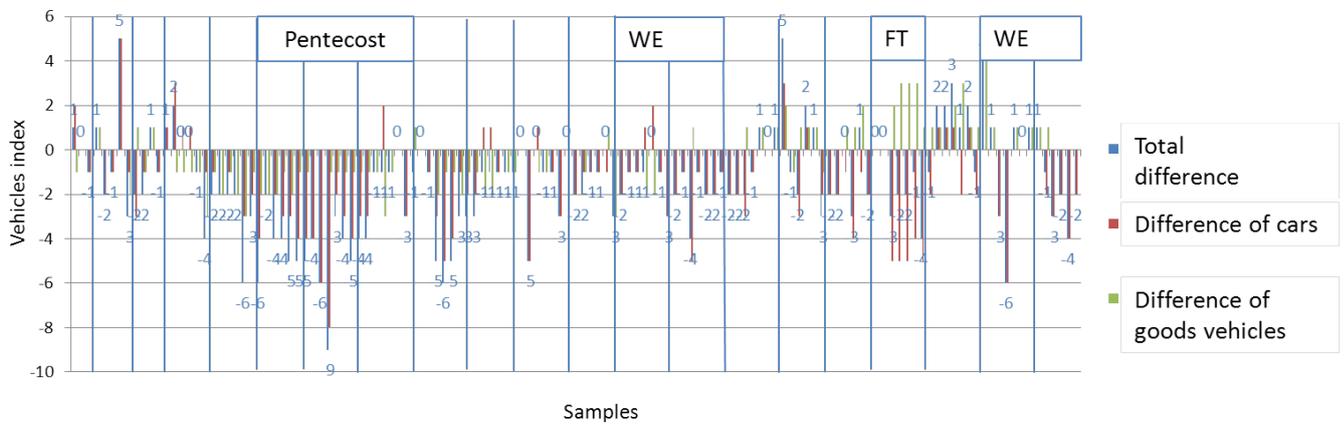
In the following chart, the total differences are given in blue numbers.

Fig. 17: Difference for all types of vehicles for total period

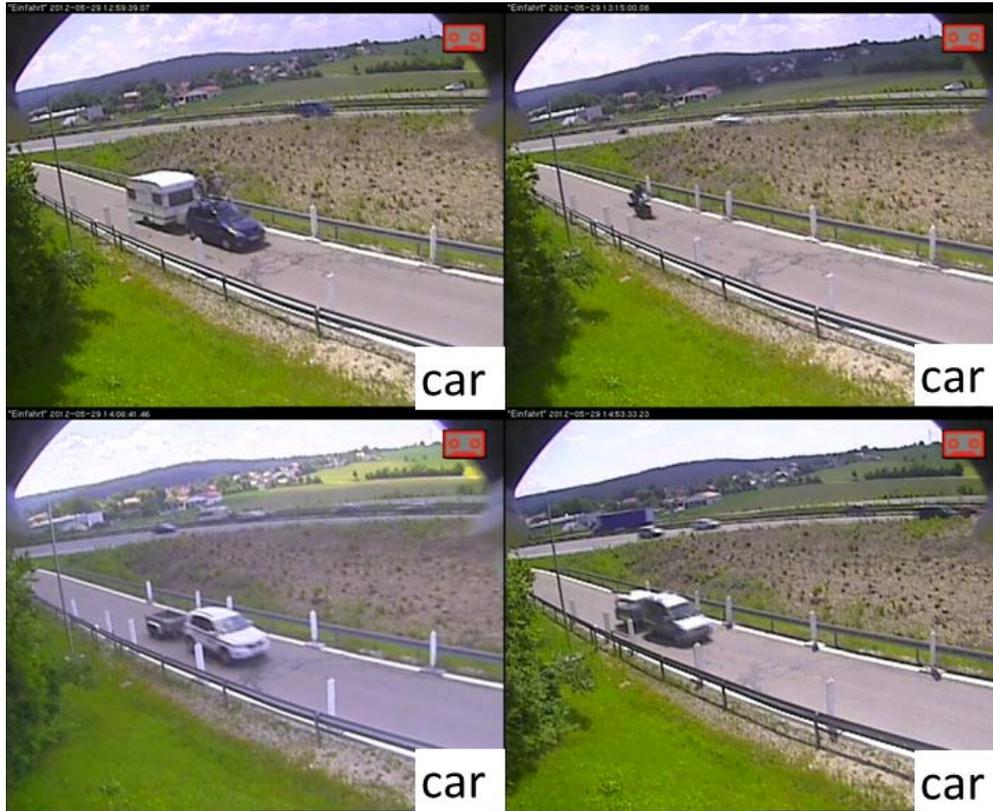
Fig. 18: Error images from 29th May 2012 with V&R-classification

Motorcycles, which were classified as cars, are counted as 'real' errors; this is the case for 5 of 1108 events (0.5 %). The remaining 20 cases (1.8 %) of non-analogy are due to the lack of definition between lorry-like and motorcar-like vehicles, (vehicle-trailer combinations classified as motorcars and not as goods vehicle as specified in TLS, caravans classified as goods vehicle along their size and not as motorcar as specified in TLS).

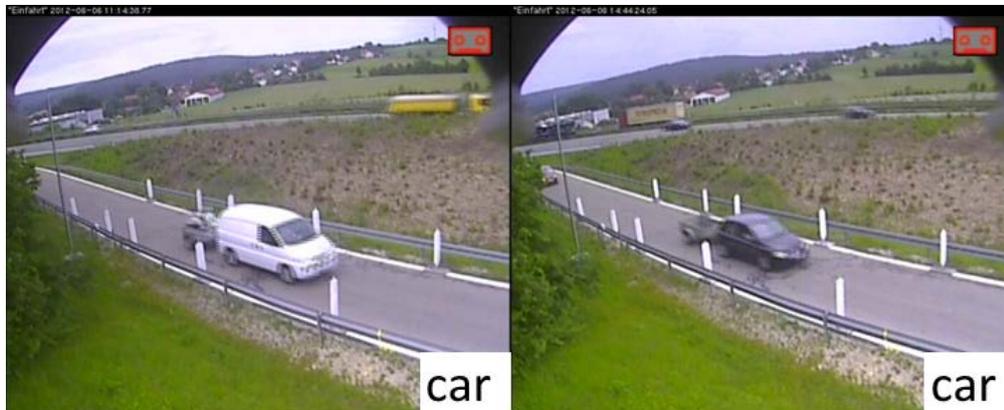
Fig. 19: Error images from 6th June 2012 with V&R-classification

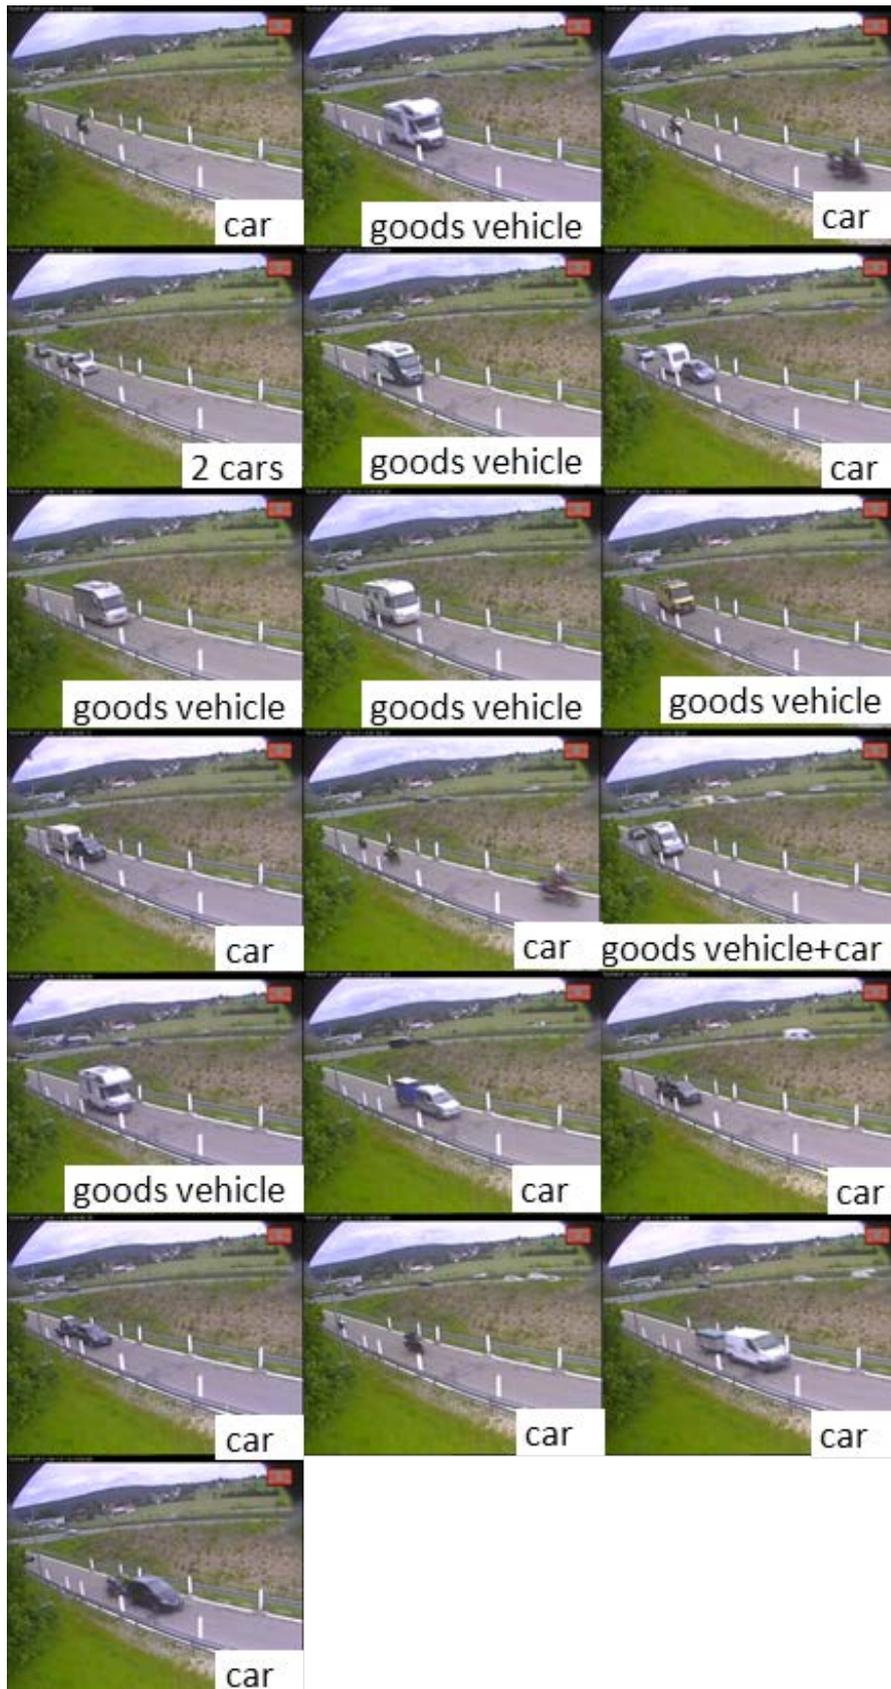
Fig. 20: Error images from 10th June 2012 with V&R-classification

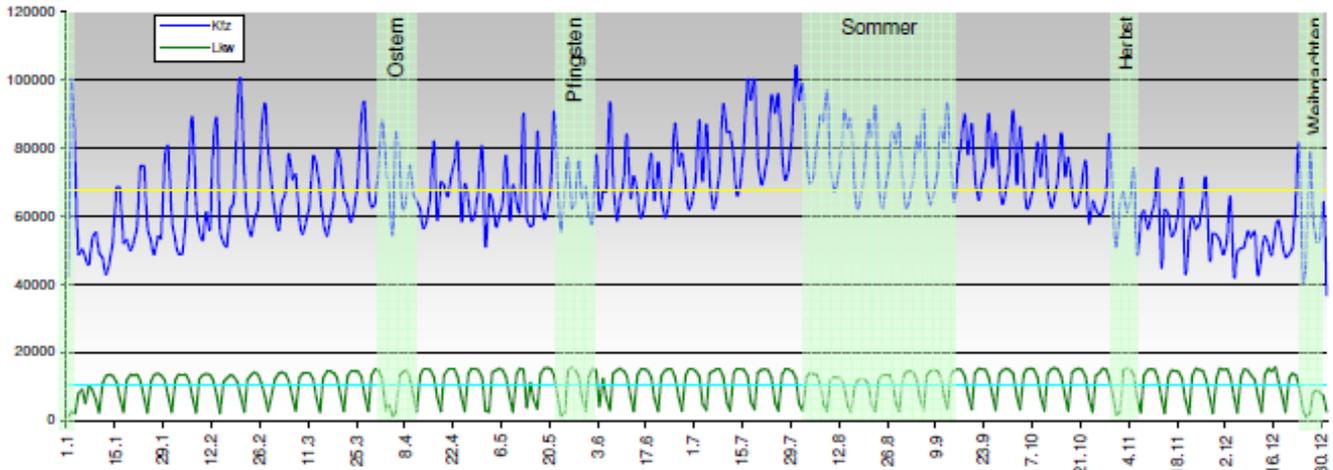
Jahresganglinien der täglichen Kfz- und Lkw-Verkehrsstärken - Gesamtquerschnitt

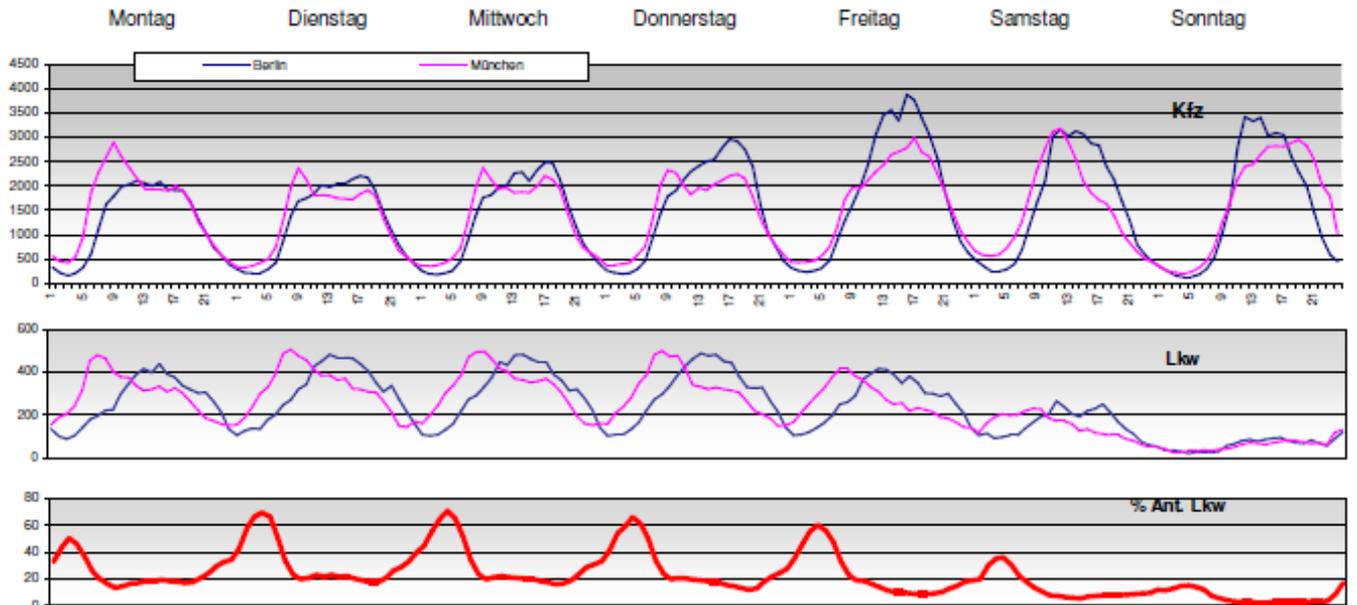
Mittlere Tagesganglinien der stündlichen Kfz- und Lkw Verkehrsstärken sowie Lkw-Anteile (Normalwochen)

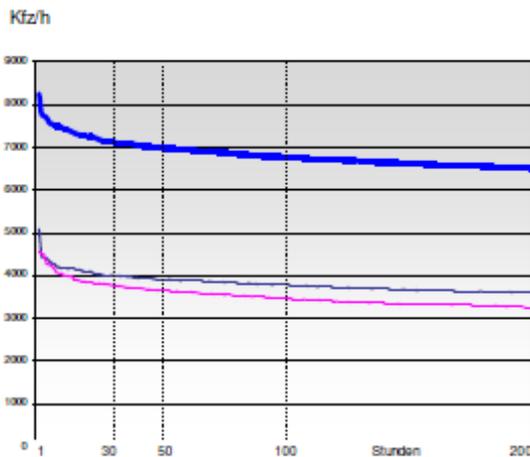
Dauerlinien der stündlichen Verkehrsstärken

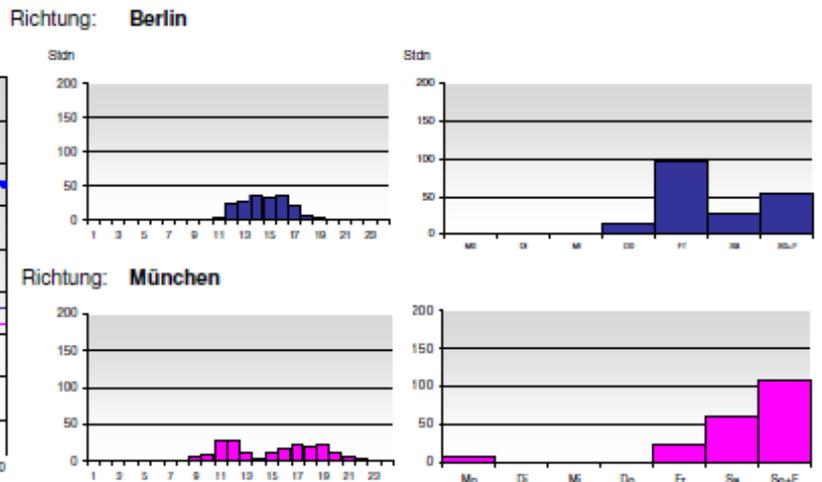
Verteilung der 200 höchsten Stunden des Jahres nach Tageszeit und Wochentagen
